WHITIANGA ACCESSIBILITY AUDIT REPORT

Thames-Coromandel District Council (TCDC) has requested an accessibility audit for the Central Business District (CBD) area of Whitianga, with particular emphasis for disabled and elderly residents. The audit covers:

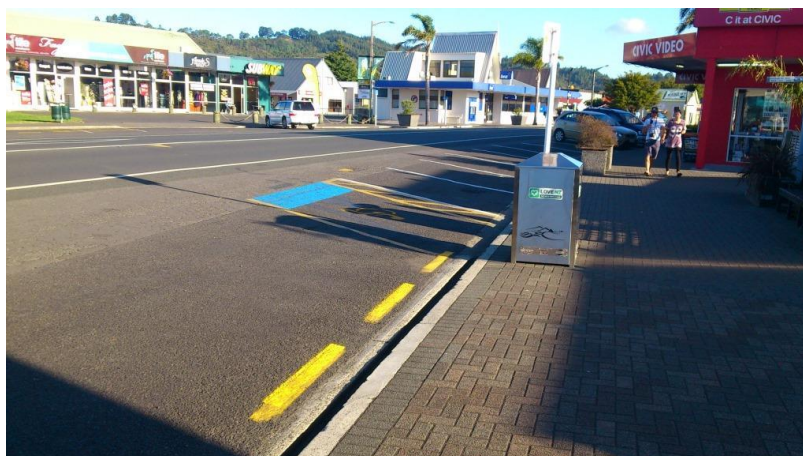
Figure 3: Mobility Space at 65 Albert Street

The only concern for the location of the existing Mobility Spaces is the one at 65 Albert Street. Moving this north to outside 59 Albert Street will provide quick access to shelter by utilising the verandah in this location.

Recommendation 4 Re-locate the Mobility Space at 65 Albert Street north to 59 Albert Street to utilise shelter from the verandah in this location.

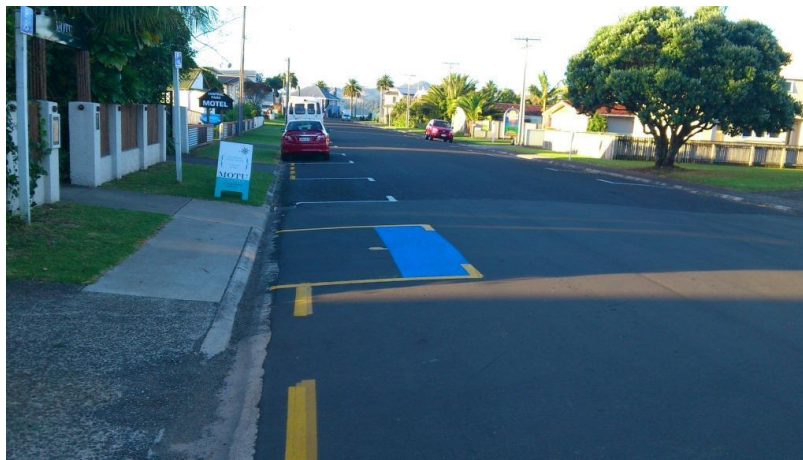
Figure 5: Mobility Space at 2 Mill Road

The Mobility Space at 2 Mill Road is placed between two kerb cut downs, making the length of the Mobility Space as 3.7m long. Extending the Space north will give enough space at the rear of the Mobility Space to avoid conflict with the driveway.

Recommendation 10 Lengthen the Mobility Space at 2 Mill Road to meet the requirements of NZS 4121:2001.

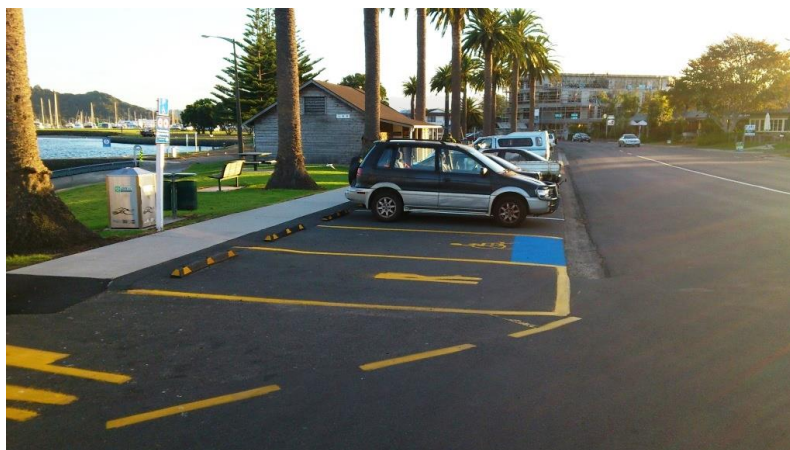
Figure 6: Mobility Space servicing the Wharf

There is a Mobility Space located at the pedestrian entrance to the wharf on the Esplanade. This measured at 3m wide, and is squeezed between two carparks. Switching the carpark with the reserved space beside it, will create the extra room needed by access users.

Recommendation 11 Switch the Mobility Space at the Wharf with the reserved space to create more usable space for access users.

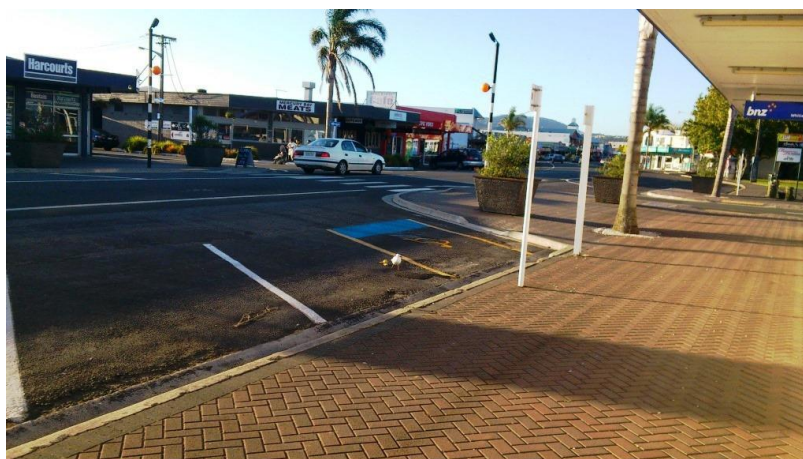
Figure 8: Mobility Space at 70 Albert Street

Overall, the condition of the Mobility Spaces provided in Whitianga is good with only the Mobility Space at 70 Albert Street needing to be re-surfaced.

Recommendation 13 Re-surface the Mobility Space at 70 Albert Street.

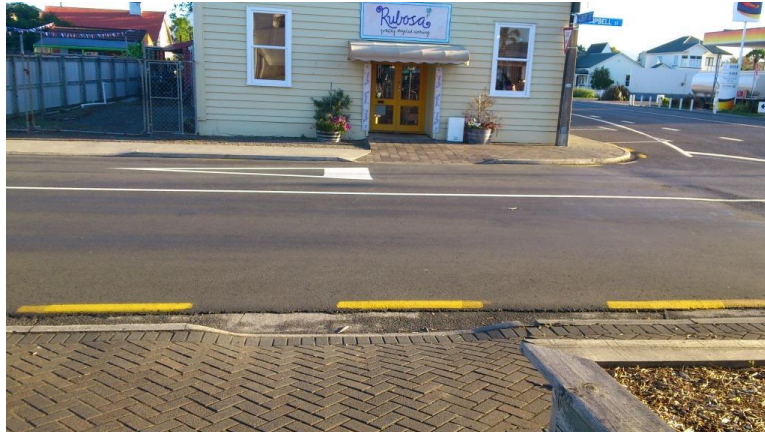
Figure 11: Albert Street/Campbell Street intersection

The intersection of Albert Street and Campbell Street has kerb ramps crossing Campbell Street only. The kerb ramps crossing the east side of Campbell Street are out of alignment. This has implications for visually impaired users in navigating the crossing point. This is further discussed in Section 9: Tactiles.

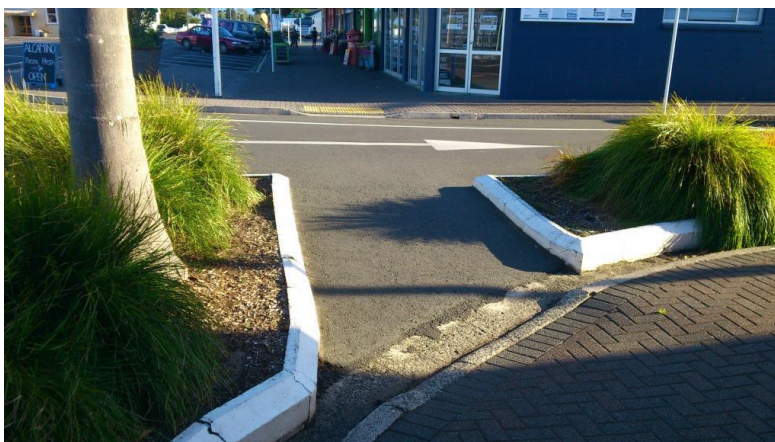
Figure 12: Crossing Coghill Street at Albert Street

The NW kerb ramp at the Albert Street/Coghill Street intersection has a lip kerb. Replacing this kerb with a flush kerb will improve access for mobility scooter and wheelchair users.

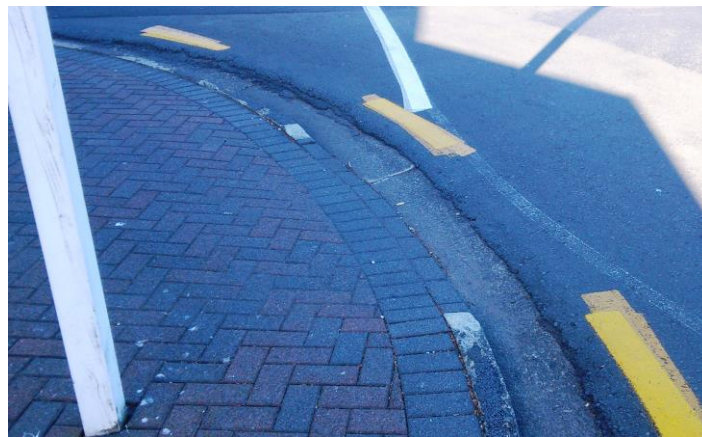
Figure 13: Kerb ramp at Albert Street/Lee Street intersection

The **Albert Street/Lee Street intersection** has kerb ramps crossing Lee Street only. Both kerb ramps have lip kerbs.

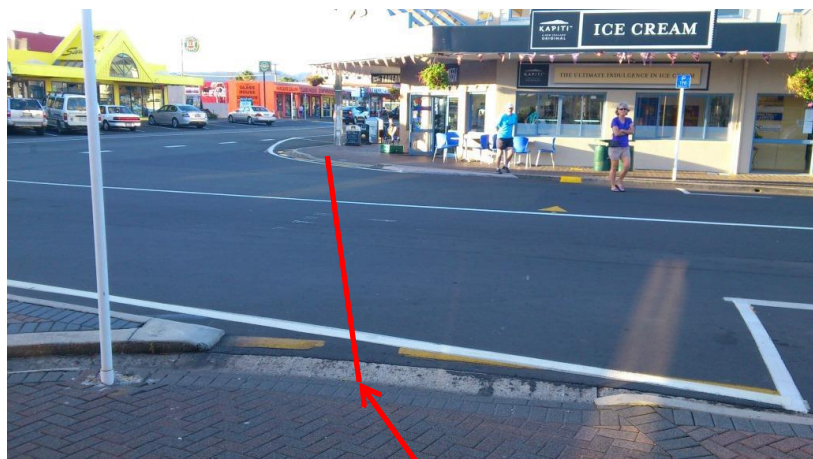
Figure 14: Albert Street/Monk Street

The **Albert Street/Monk Street intersection** would be considered as the centre of Whitianga. At this intersection, the kerb ramps do not line up and both have lip kerbs.

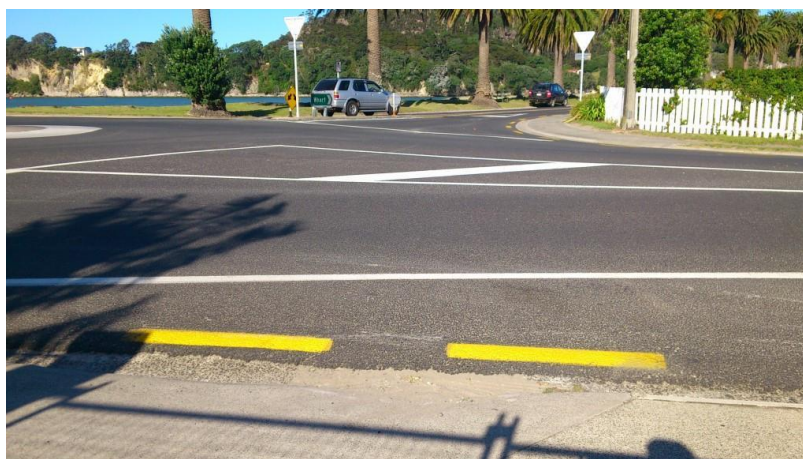
Figure 15: Crossing Albert Street at Buffalo Road.

There are no kerb ramps crossing the Esplanade at this intersection.

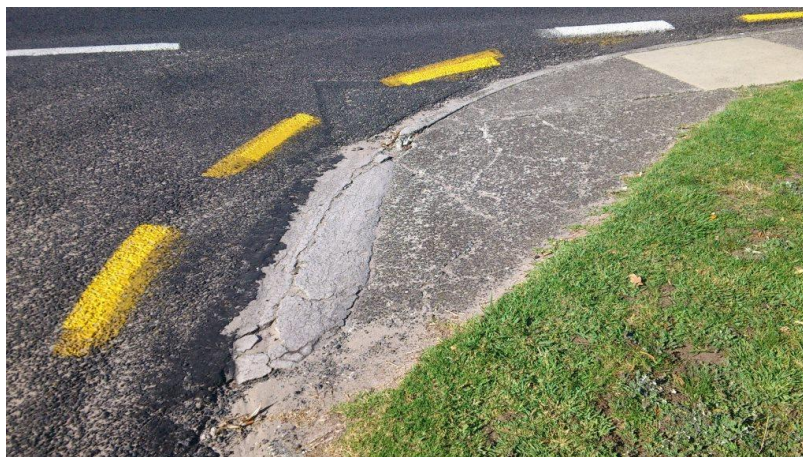
Figure 16: Kerb ramp on the east side crossing Eyre Street at Buffalo Beach Road

The SE kerb ramp crossing Eyre Street is uneven and broken (creating a tripping hazard), while the NW kerb ramp crossing Eyre Street utilises the driveway at 2a Eyre Street (Waterfront Apartments Whitianga). This extremely dangerous practise as a mobility scooter or wheelchair user is lower to the ground and is harder to see for vehicles reversing.

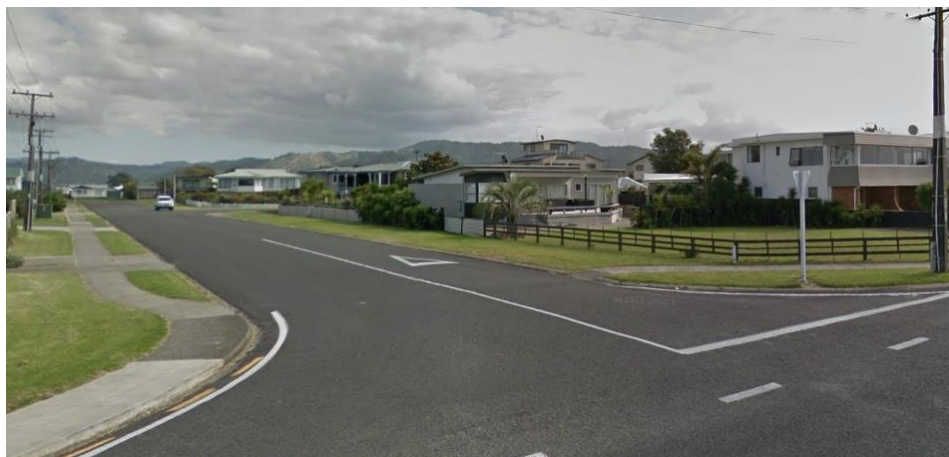
Figure 17: Buffalo Beach Road/Halligan Road intersection

There are no kerb ramps for crossing Buffalo Beach Road at this intersection.

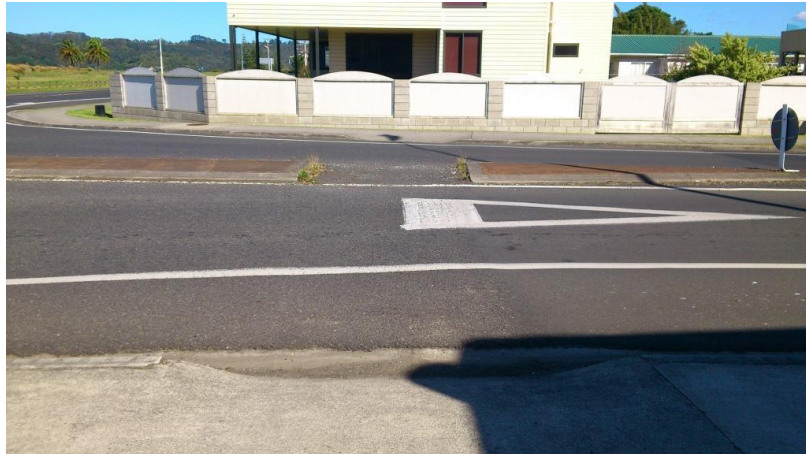
Figure 19: Kerb ramps at Buffalo Beach Road/SH.25 intersection

The kerb ramp on the north side of SH.25 has a grade of 1 in 8.3 (12.1%), while the kerb on the south side of SH.25 has a grade of 1 in 9.1 (11%).

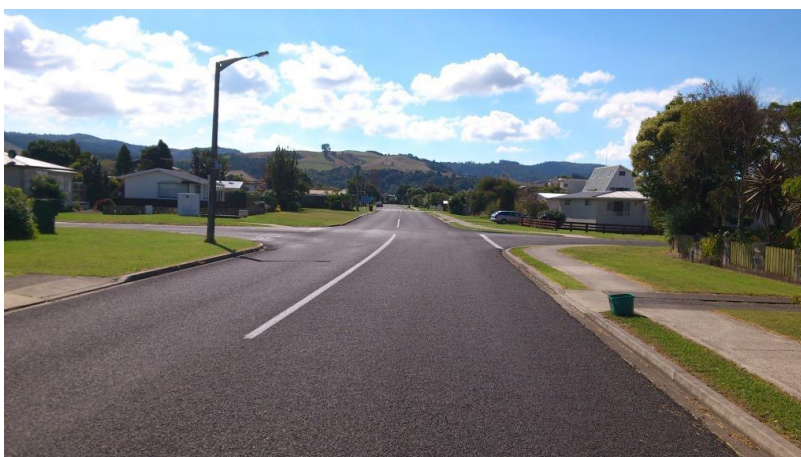
Figure 21: Cook Drive/Jackman Avenue intersection

The NE kerb ramp crossing Jackman Avenue at the **Cook Drive/Jackman Avenue intersection** is at a grade of 1 in 8.8 (11.3%) while the NW kerb ramp crossing Cook Drive was measured at a grade of 1 in 9.4 (10.6%). The SE kerb ramp crossing Jackman Avenue has a lip kerb and there is no kerb ramp at the NE side crossing Cook Drive.

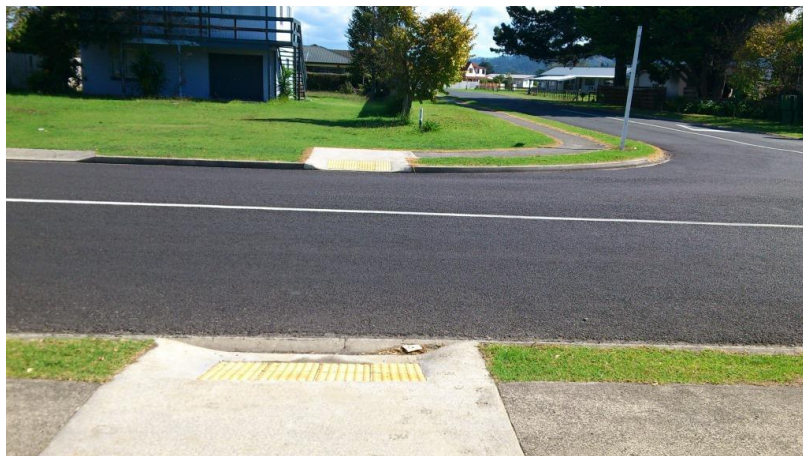
Figure 22: Cook Drive/Park lane intersection

A new connection has been installed at the **intersection of Cook Drive and Park Lane** which now connects the footpath on Park Lane. The kerb ramp on the east side crossing Cook Drive is at a grade of 1 in 4.7 (21.5%) and the kerb ramp on the west side crossing Cook Drive has a lip kerb.

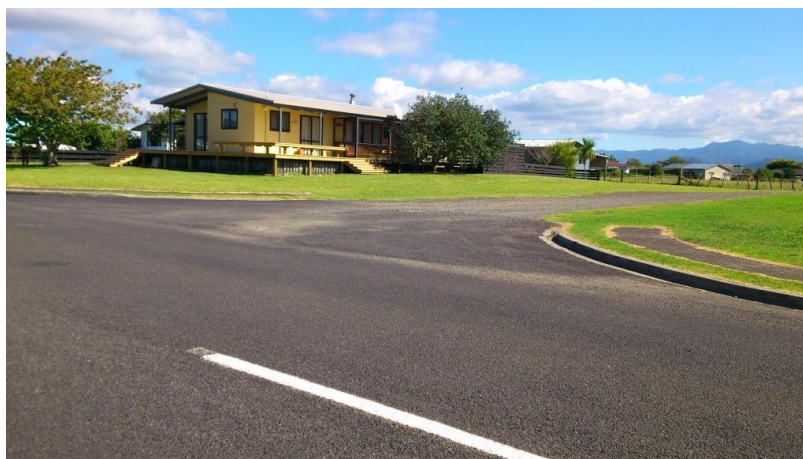
Figure 23: Side Road approx. 300m south of Park Lane along Cook Drive

Approx. 300m south of Park Lane along **Cook Drive is a small side road with a formed intersection**. Kerb ramps are missing for crossing this road.

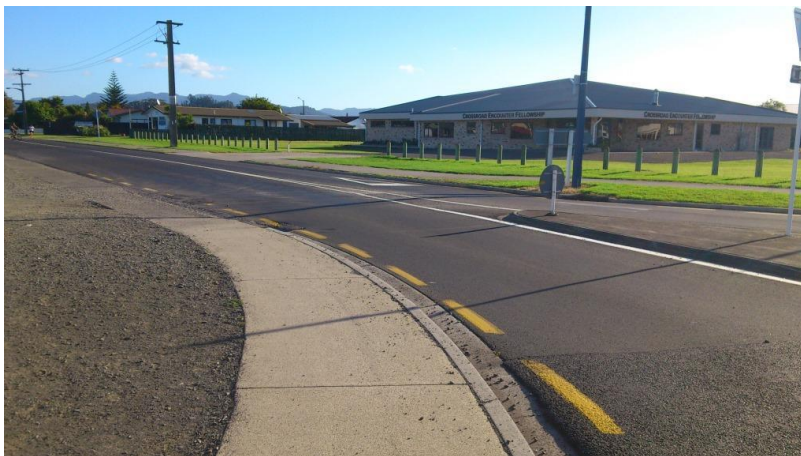
Figure 24: Crossing Cook Drive south of Joan Gaskill Drive

The kerb ramp on the SW corner crossing Joan Gaskill Drive has a grade of 1 in 10.4 (9.6%) while the NW kerb ramp crossing Joan Gaskill Drive has a grade of 1 in 8.9 (11.2%). There is a kerb ramp missing on the SE and SW corners crossing Cook Drive.

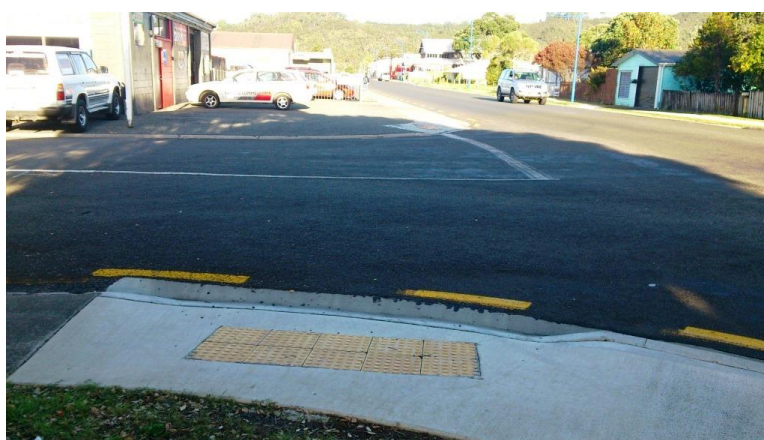
Figure 25: Campbell Street/Mary Street intersection

The kerb ramps on the north side of Campbell Street at the **intersection of Campbell Street and Mary Street** are not correctly aligned. This creates difficulties for visually impaired users to negotiate the intersection.

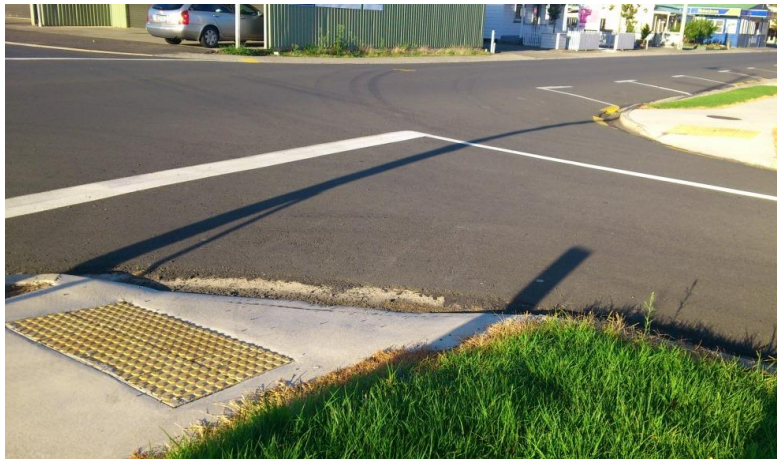
Figure 26: Campbell Street/Isabella Street intersection

The north side of Campbell Street (crossing Isabella Street) has very narrow kerb ramps on both sides while there are no kerb ramps for crossing Campbell Street at this intersection.

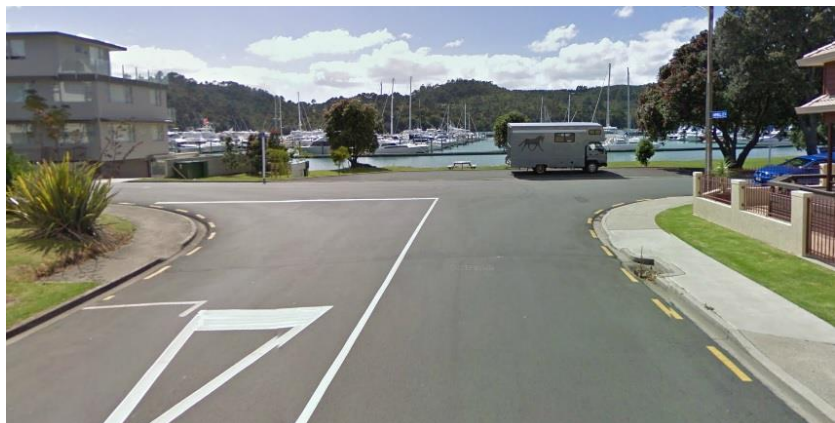
Figure 27: Campbell Street/Victoria Street intersection

At the **intersection of Campbell Street and Victoria Street**, the kerb ramp on the north side of Campbell Street, the kerb ramp is very narrow. This is the same for both kerb ramps at the **Owen Street/Victoria Street intersection**.

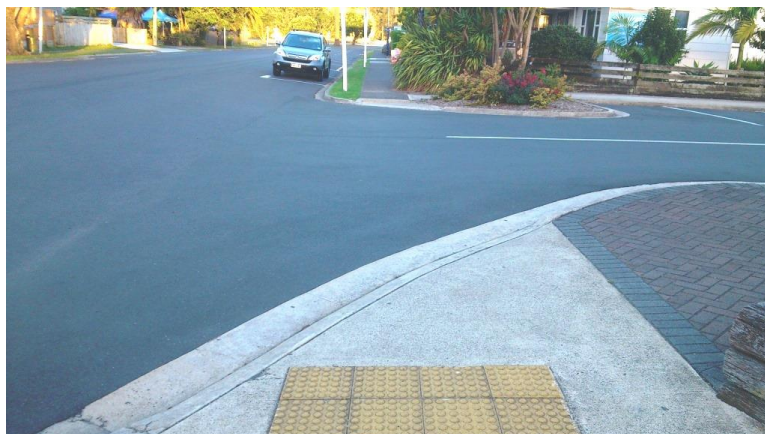
Monk Street provides a pedestrian link from the centre of town to the Wharf. New kerb ramps have been installed at the carpark opposite Mill Road that, although are flush, the face of the kerb is very steep and acts like a lip kerb.

Figure 28: Steep kerb face on Monk Street

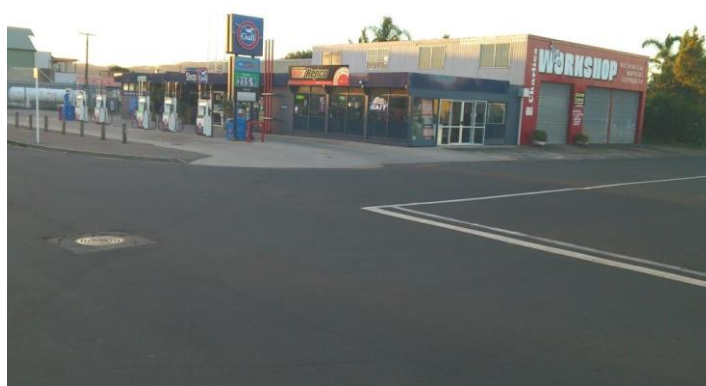
The kerb ramp for the west side of the intersection utilises the vehicle entrance to the Gull Service Station. This practise is extremely dangerous for accessibility users who are unable to move quickly out of the way from a distracted driver.

Figure 29: Using the vehicle entrance at the Gull Service Station on Monk Street as a kerb ramp

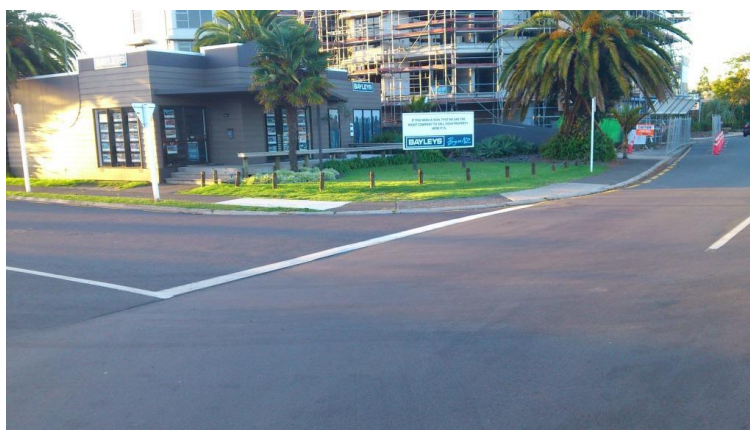
The **Esplanade/Monk Street intersection** has a kerb ramp on the south side crossing Monk Street with a grade of 1 in 8.7 (11.5%), while the north side crossing Monk Street is missing a kerb ramp.

Figure 30: Missing kerb ramp at the Esplanade/Monk Street intersection

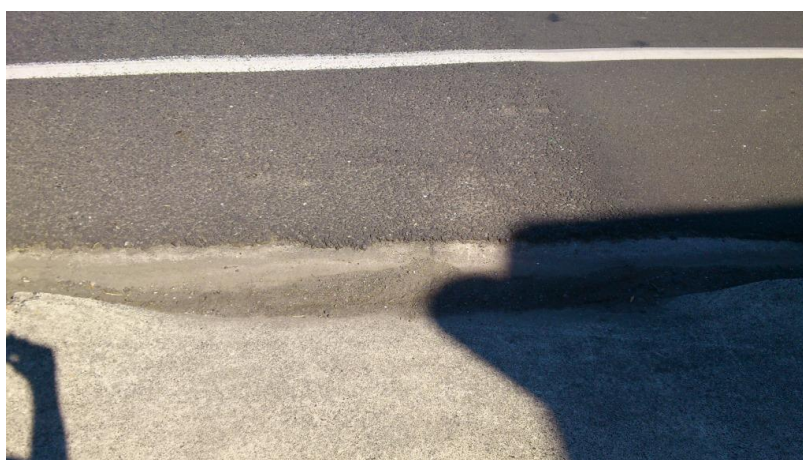
Figure 31: Seal edge join after re-sealing at Buffalo Beach Road/SH.25 intersection

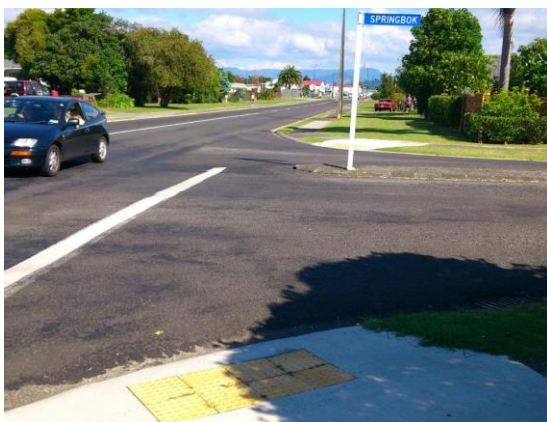
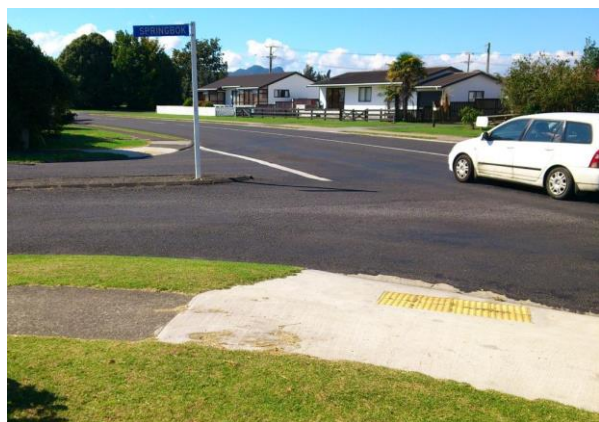
The Tactiles at the intersection of Cook Drive/Springbok Avenue need re-alignment.

Figure 35: Tactiles directing visually impaired users into the intersection of Cook Drive/Springbok Avenue

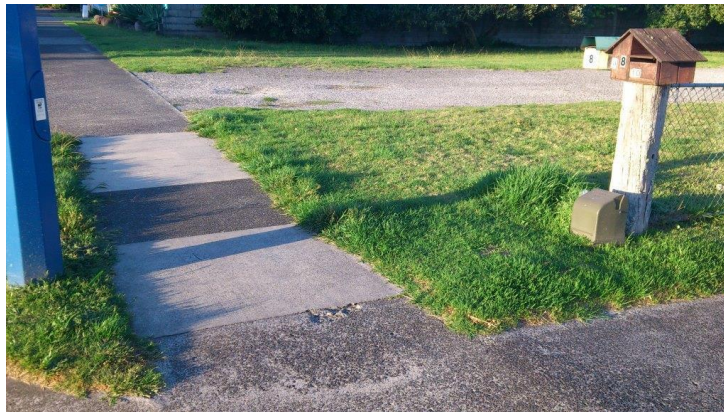
Figure 43: Broken concrete at join 8-10 Albert Street

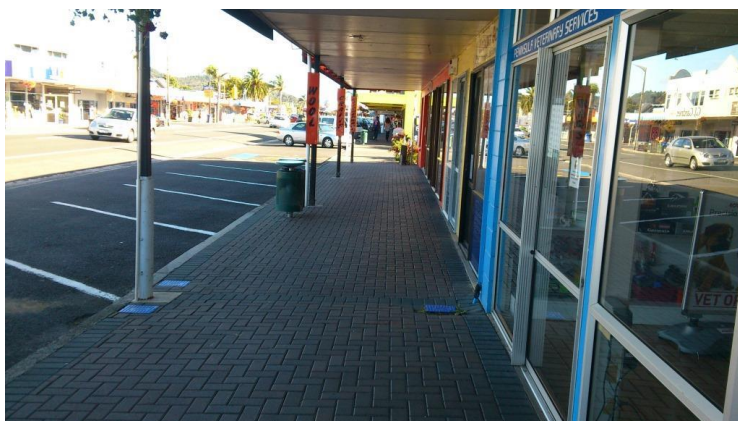
Figure 46: Service cover at 23 Albert Street

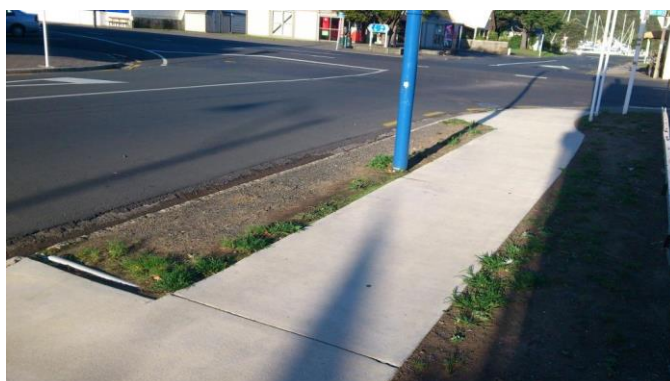
Figure 47: Berm repair required on Campbell Street

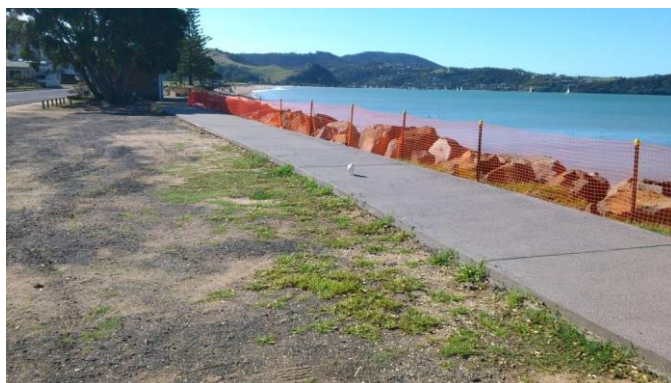
Figure 48: Berm repair required along walkway

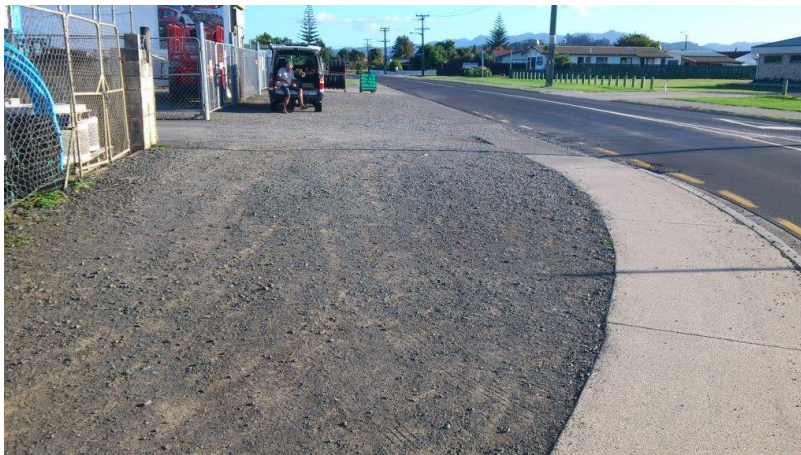
Figure 50: Loose metal on footpath at Cook Drive/Campbell Street intersection

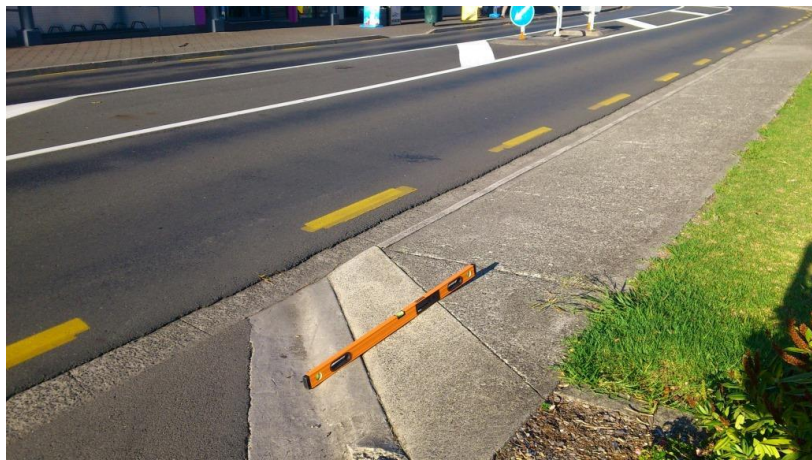
Figure 51: steep longitudinal gradient at the entrance to Lee Street Carpark
