WHITIANGA ACCESSIBILITY AUDIT REPORT

Thames-Coromandel District Council (TCDC) has requested an accessibility audit for the Central Business District (CBD) area of Whitianga, with particular emphasis for disabled and elderly residents. The audit covers:

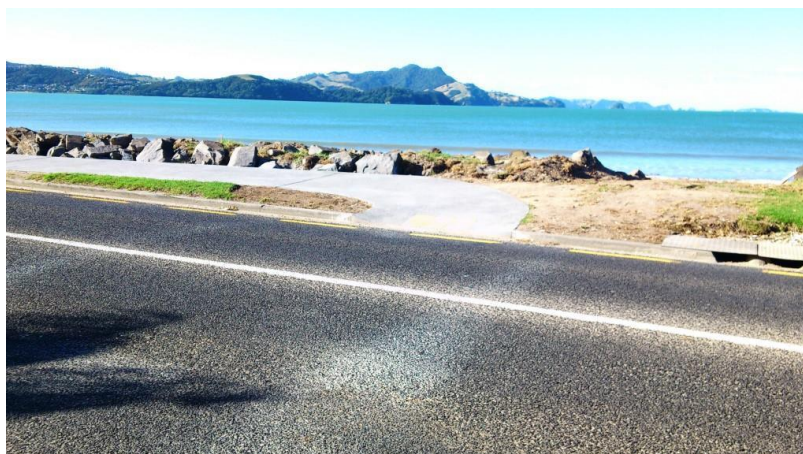
Figure 33: Crossing Buffalo Beach Road at Albert Street

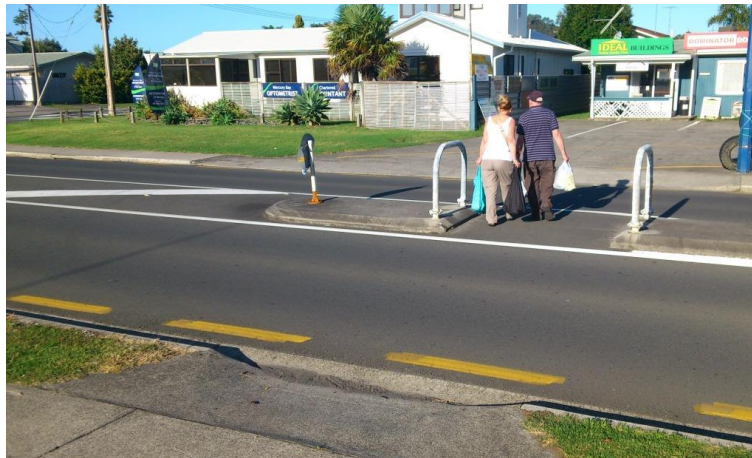
Figure 34: Refuge Island on Cook Drive - between Lee Street and Campbell Street

The following locations require the installation of both Warning Indicators and Directional Indicators:

- Jackman Avenue – SE corner crossing Jackman Avenue;
- Lee Street – both sides crossing Lee Street;
- Two mid-block refuge islands between Lee Street and Campbell Street – both sides;

The only adjustments to be made to the existing refuge island on Cook Drive, between Lee Street and Campbell Street (see figure 34).

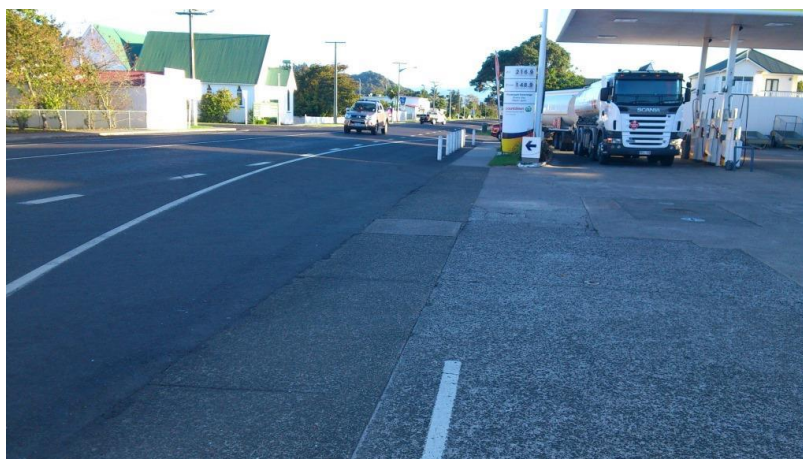
Sometimes it is necessary to provide contrasting visual guidance without the need for installing Warning or Directional Indicators. A yellow guideline at the boundary of the Z Service Station at the Albert Street/Campbell Street intersection and at the Gull Service Station at the Monk Street/Mill Road intersection will provide delineation of the footpath for visually impaired users.

Figure 36: Vehicle entrance to the Z Service Station at the intersection of Albert Street and Campbell Street

Recommendation 66 Install yellow lines at the Service Station at the intersections of Albert Street/Campbell Street and Monk Street/Mill Road to delineate the footpath.

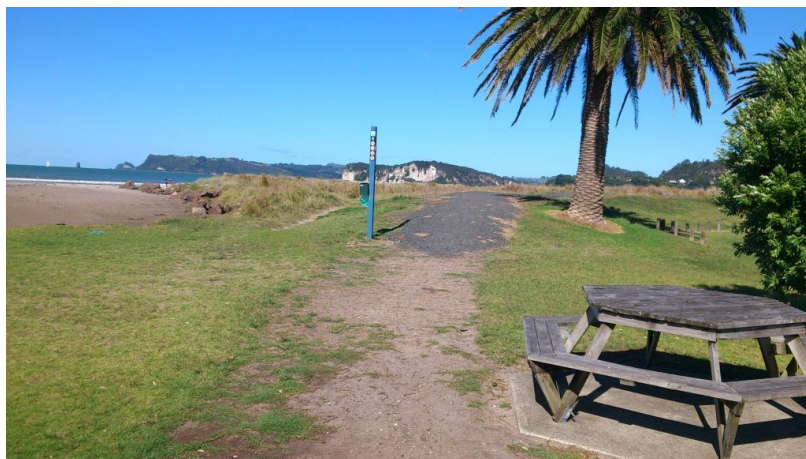
Buffalo Beach Road runs parallel to the Whitianga Beach. A walkway is currently under construction on the east side with views over the beach. Extending this walkway for a further 820m will complete this pedestrian network to SH.25.

Extending the walkway approx. 380m east to the Wharf along the Esplanade will complete the connection from SH.25 to the Wharf.

Figure 37: Track on east side of Buffalo Beach Road near SH.25

Recommendation 69 Extend the walkway under construction on the east side of Buffalo Beach Road for a further 820m to complete the pedestrian network to SH.25. Extend the walkway approx. 380m west along the Esplanade to connect SH.25 to the Wharf

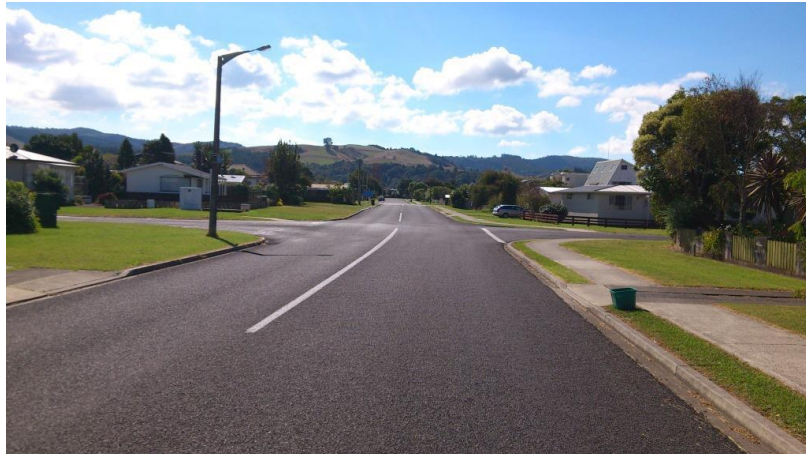
The footpath on the west side of Cook Drive starts at 116 Cook Drive, and heads south to Joan Gaskill Drive.

To suit the requirements of the PPDG, approx. 750m of footpath from 116 Cook Drive to Surf Street is required to complete the pedestrian network on Cook Drive.

Figure 38: Cook Drive - looking north

Recommendation 70 Extend the footpath on Cook Drive approx. 750m from 116 Cook Drive to Surf Street.

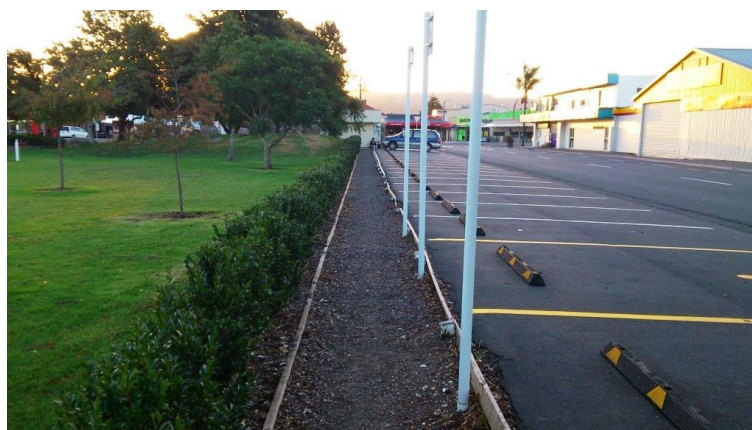
Blacksmith Lane connects Albert Street to the Library. A metal path is located at the front of the 90° carparking available on the south side from Albert Street to Victoria Street.

Figure 39: Blacksmith lane

Providing a footpath connection will improve access to the Library from the Public Toilets and Albert Street as well as safe access from the three Mobility Spaces.

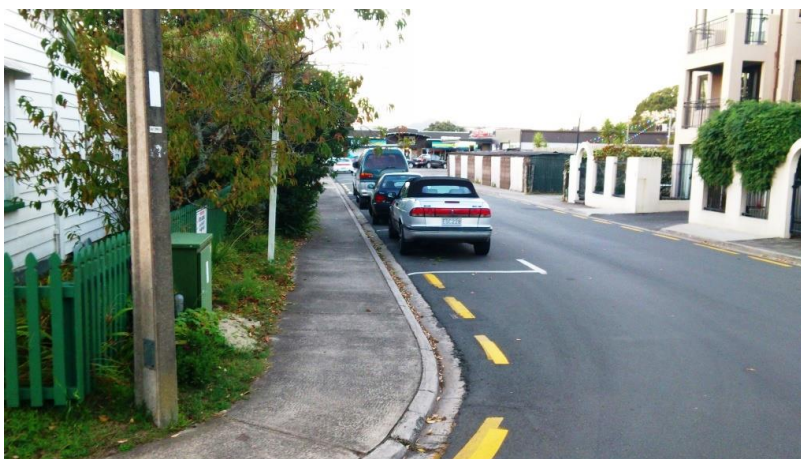
The only area of concern for vegetation was at 20 Victoria Street.

Figure 41: Vegetation at 20 Victoria Street

Recommendation 73 Maintain the footpath widths by liaising with adjoining land owners to trim vegetation extending from the boundary over the footpath.

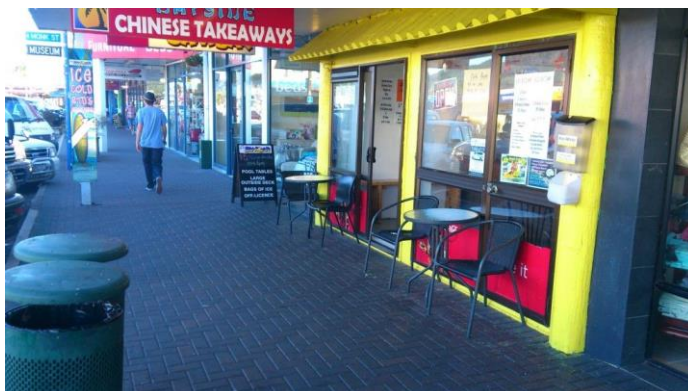
Figure 42: Cobblestones on Albert Street

The main concern is the potential for introducing tripping hazards when the cobblestones settle, particularly when reinstated after underground service work. Unless the supporting aggregate is evenly compacted, the cobblestones will settle unevenly. The end result will then create small tripping hazards where the cobblestones join.

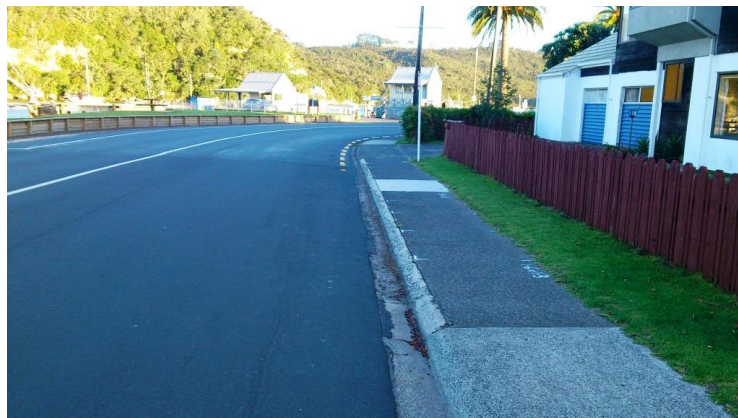
Throughout the site investigation, defects in the footpath were marked for repair. This was very pleasing to see as it shows TCDC has a good maintenance programme in place.

Figure 44: Footpath repair marking on Esplanade

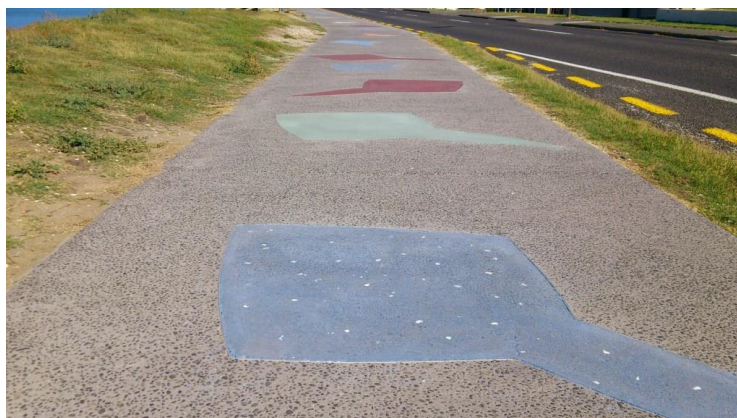
Figure 45: Design imprints on the walkway along Buffalo Beach Road

- Design imprint frames on walkway along Buffalo Road (need to be flush);

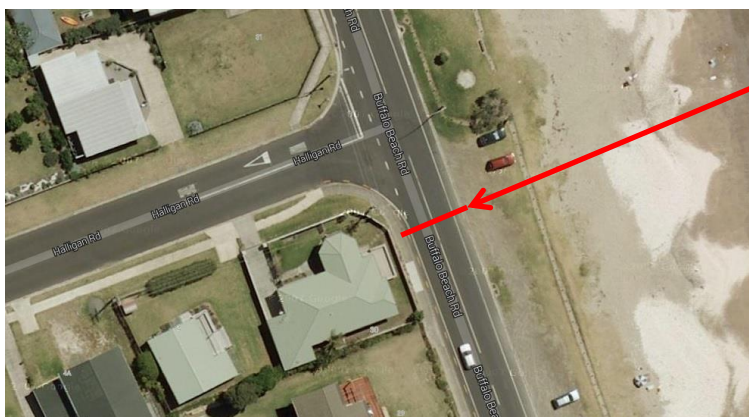
The Community Consultation Meeting raised the need for a connection from Whitianga Continuing Care to the beach accesses on **Buffalo Beach Road**. An ideal access would be immediately south of Halligan Road.

Proposed location for crossing facility on Buffalo Beach Road

Figure 55: Proposed crossing location on Buffalo Beach Road – linking Whitianga Continuing Care to the Beach.

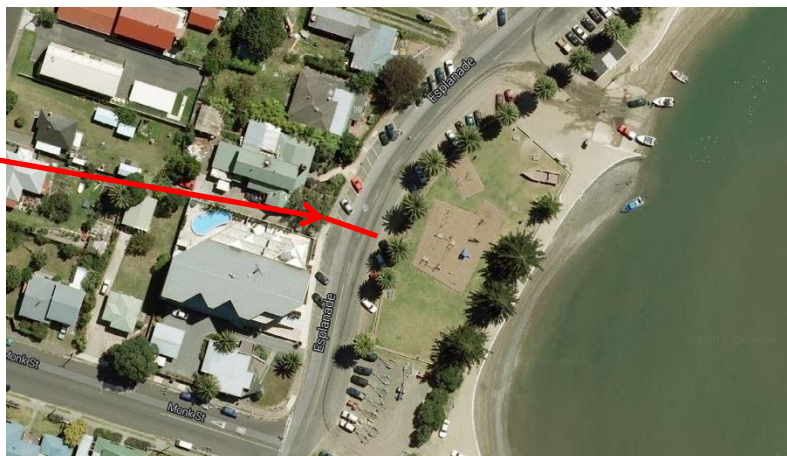
Figure 56: Proposed crossing facility on Esplanade – between the Wharf and Monk Street

Recommendation 66 and installing a crossing facility by the playground will complete a pedestrian route from the wharf to town.

The ADT volume for Esplanade is 629 veh./day.

Recommendation 86 An appropriate crossing facility is recommended on Esplanade, between the Wharf and Monk Street. Details should be finalised after analysis using the Pedestrian Crossing Facilities Calculation Spreadsheet.

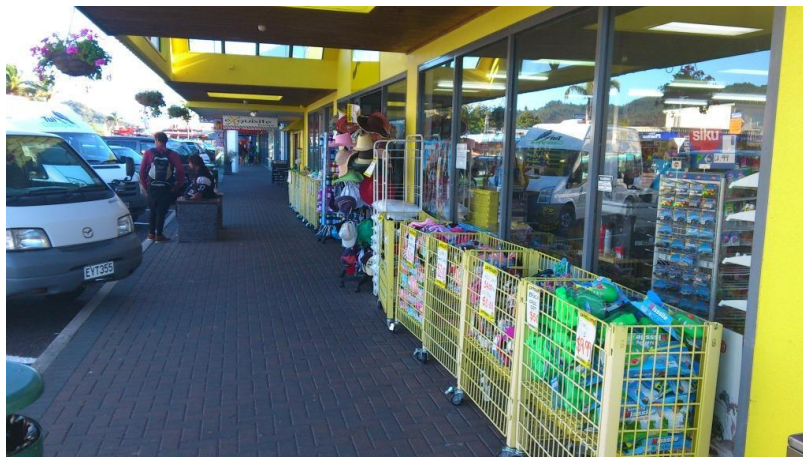
Figure 57: shop stock on Albert Street

Businesses along Albert Street regularly install street signage and stock outside of their premises. This has implications for people with significant visual impairment as they frequently use environmental cues such as buildings to navigate around a community and they won't necessarily see stock that are low to the ground, they become a trip hazard.

By having obstacles on the shop boundary, visually impaired people are forced to use the kerb line as a navigation aid.

Recommendation 89 Liaise with business owners to retain clear access route widths and keeping the building line clear of al-fresco dining furniture, signage and stock for sale.

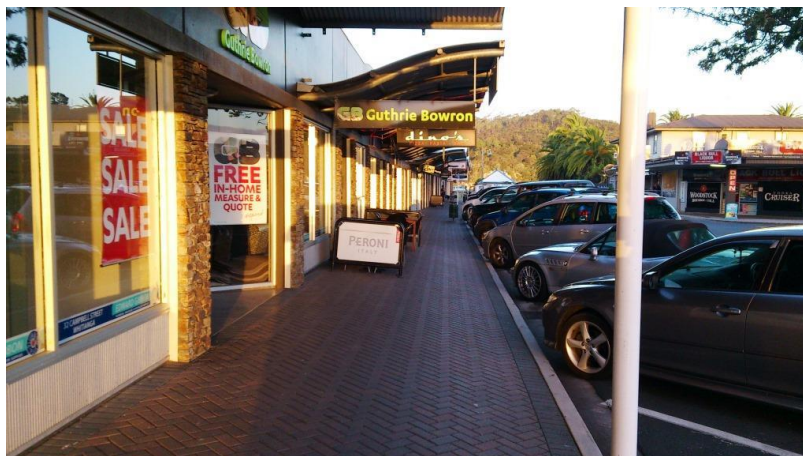
Figure 58: Al-fresco dining on Blacksmith Lane

Al-fresco dining cause similar issues, this time loose tables and chairs become obstacles.

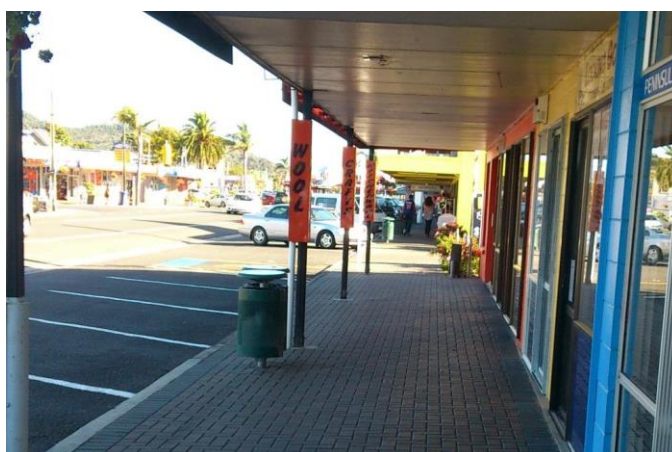
Figure 60: Rubbish Bin located near the kerb on Albert Street

There are a number of rubbish bins in Whitianga. These are very well located near the kerb edge and are easily accessible to use.

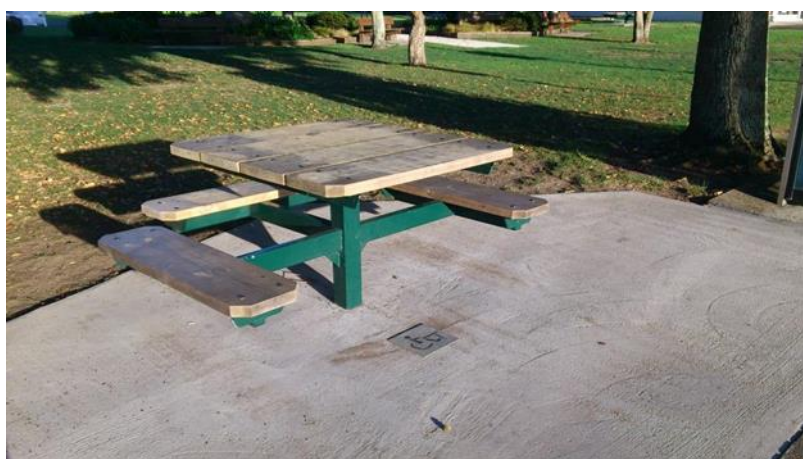
Figure 61: Public seating on Albert Street

Figure 61 shows an excellent example of seating catering for wheelchair users. This seat is located on Albert Street and is used as an example to other Local Authorities and Community Boards on provisions for seating.

Recommendation 90 Adopt the Inclusive Design for Getting Outdoors as part of its design for public seating.

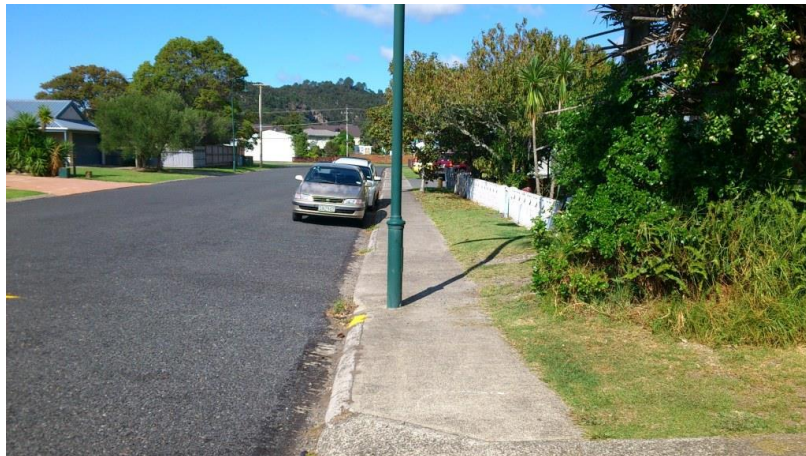
Figure 62: Light Pole opposite School House lane at School Road

The placement of power poles can be a nuisance for pedestrians, particularly visually impaired users. Given that power poles are mostly concrete, they blend in with the surroundings and can be difficult to see.

One light pole on School Road is near the centre of the footpath. Widening the footpath as recommended in Section 10: Footpaths will remove this barrier.

Recommendation 91 Widen the footpath on School Road to provide width at the light pole opposite School House Lane.
